Seals and Packings, Inc. – Burly Seals
Products Co.
1900 Jay Ell Drive
Richardson, Texas 75081

Burly Seal Self-Implementing PCB Cleanup and Disposal Work Plan Addendum

May 2012

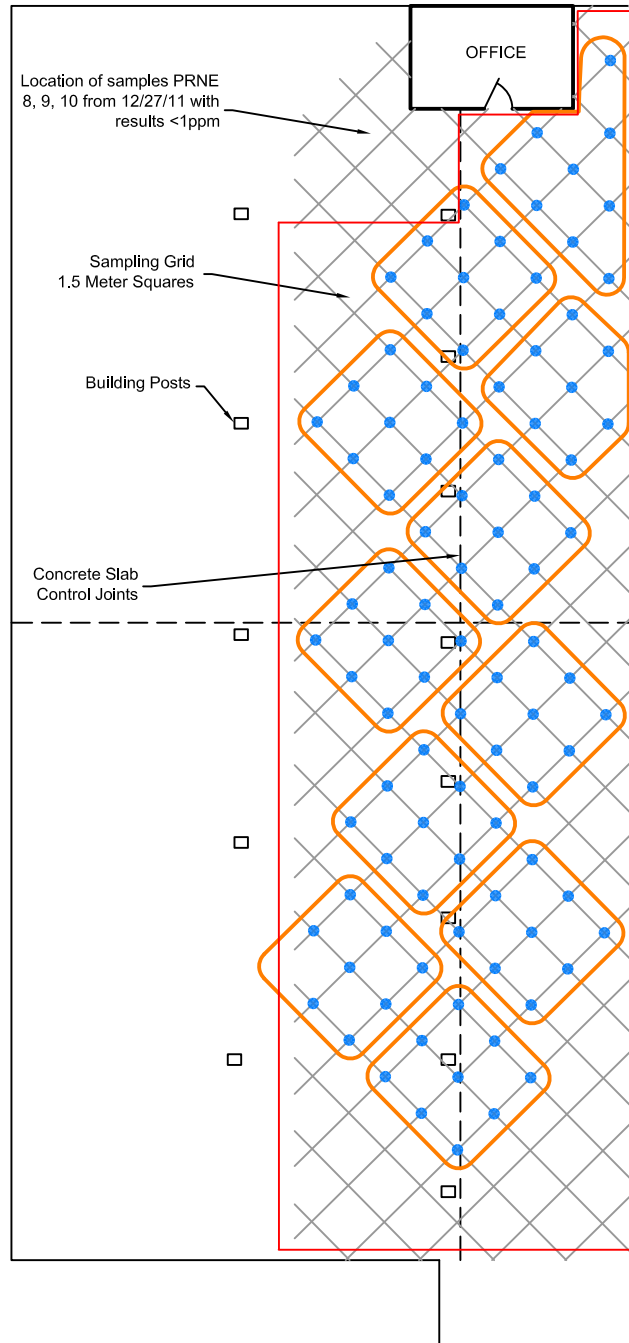
Figure 3
*Proposed Verification Sampling Locations - Press Room
 Burly Seal - 1865 West D Avenue, Building 604
 Tooele, Utan*

Because the affected area of the concrete slab will be removed in its entirety, ERM will perform verification sampling of the underlying soil using the 1.5 meter grid described in Subpart O. Potential migration of PCBs through the slab would be most likely occur along the slab seams. For that reason, the verification sampling will focus on areas beneath the slab seams as shown on Figure 3.

Recommendation: We plan to remove the portion of the slab that does not meet the cleanup goal. As described in the original Work Plan, we still intend to remove approximately 3-4 cubic yards of soil from beneath the slab seams, where the seams have allowed oil containing PCBs to migrate into the underlying soil. Once the slab is removed, any soil with visual evidence of oil will also be removed. The debris at the base of the pillars sampled by the EPA will be removed during the floor removal.

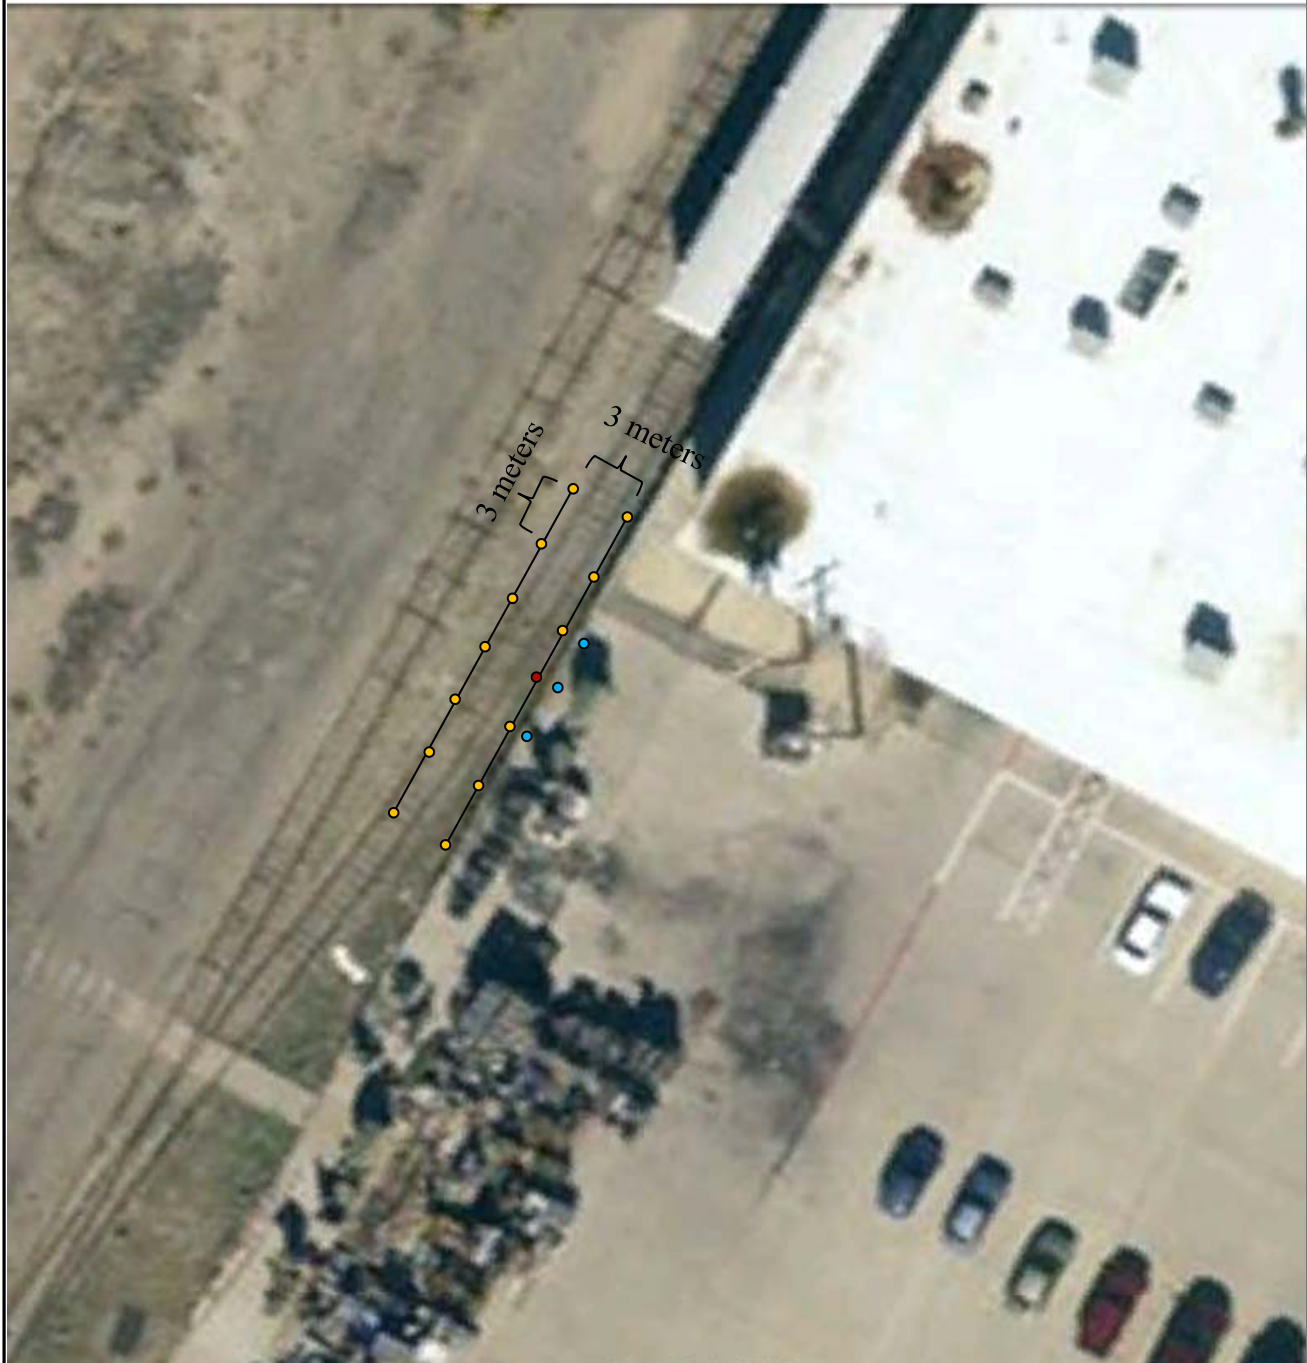
**Figure 4 - Proposed Additional Characterization Samples,
Railroad Tracks Area
Burly Seal - 1865 West D Avenue, Building 604
Tooele, Utah**

The EPA collected a sample of soil (OS-3) from between the parking lot retaining wall and the railroad tracks on the west side of the Burly Seal parking area. The sample location was approximately 11.5 feet west and 28 feet south of the southwest corner of the building, and directly west of the general vicinity of the former location of the MP Environmental bin.

The result was 500 ppm PCBs. The source of the PCBs in this area is not known.

Recommendation: We recommend performing additional characterization sampling in the area around Sample OS-3 to determine whether this result is representative of general elevated PCB levels or is an isolated hot spot. To further characterize the area, we propose to resample at location OS-3, and collect three discrete samples from the concrete in the parking lot near OS-3 and 14 soil samples from the railroad track area in accordance with regulatory requirements for PCB characterization. The samples will be spaced three meters apart as shown on Figure 4.

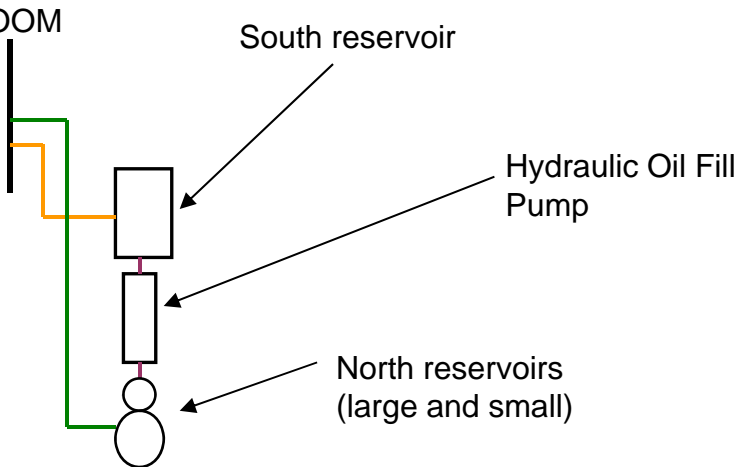
Appendix A
Schematic of Removed Press System Equipment

The table below provides a summary of the materials that were removed by flatbed truck. A schematic showing the press system equipment and configuration prior to removal is included as Appendix A.

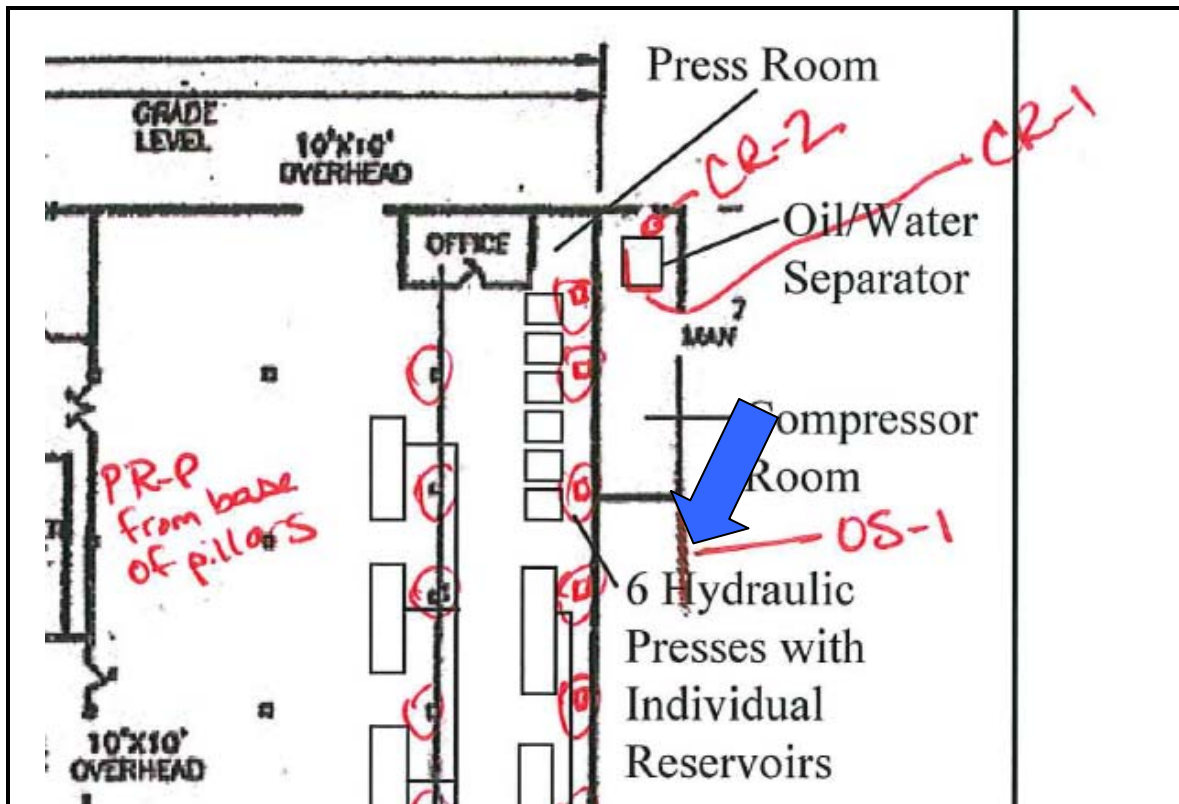
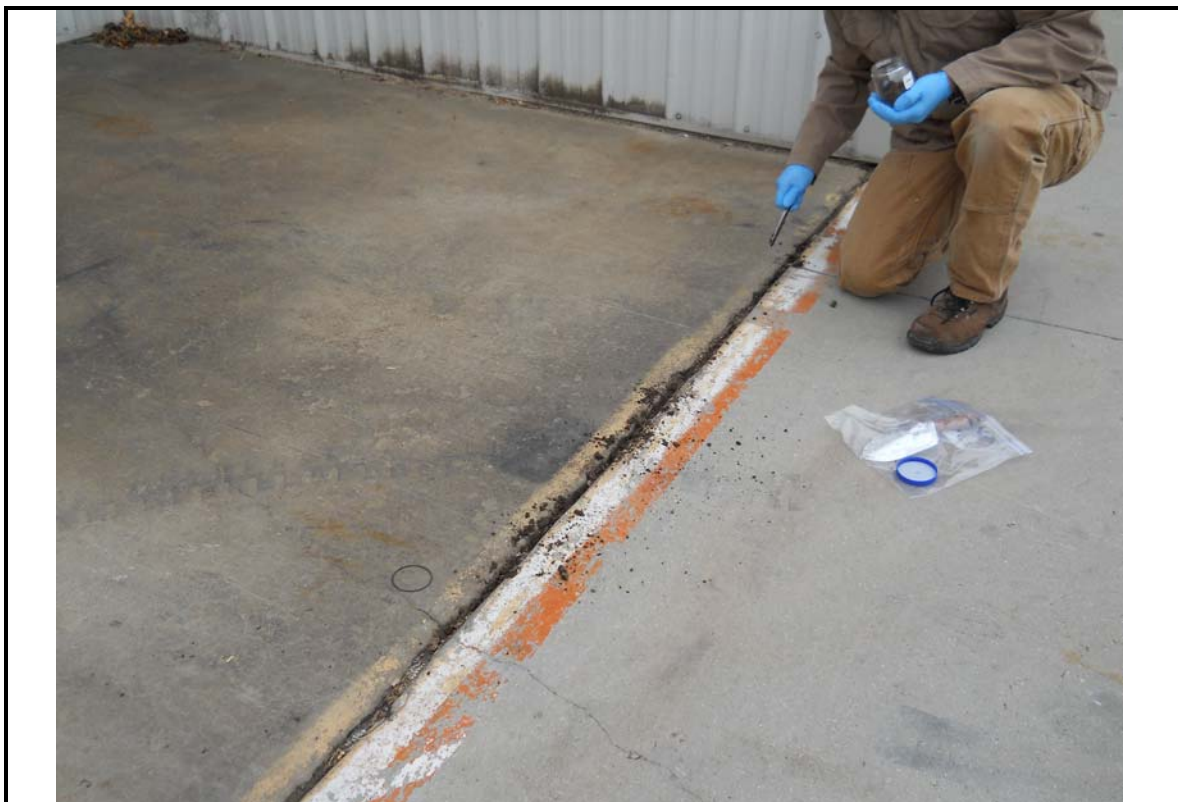
Sample OS-1
21 ppm
Collected by EPA 12-20-11

A concrete sample (composite of 4 individual samples on a three meter grid) was taken by ERM from the parking lot in the area of the former tote storage (TS-1). This sample was taken at the request of Cheryl Turcotte of the EPA. The result was 2.7 ppm PCBs. The EPA collected a sample of soil from the seam in the concrete in this same area (OS-1). The result was 21 ppm PCBs.

Recommendation: We plan to remove the soil from the seam in the concrete using a pressure washer and then clean the concrete in the area. We will take one confirmation sample of the concrete by sampling four points on a three meter grid and compositing the four samples. The confirmation sampling grid will be moved one meter north and one meter east from the original sample location. Because the soil will be removed from the seam through the cleaning, there will be no soil remaining and no soil confirmation sampling in this area.

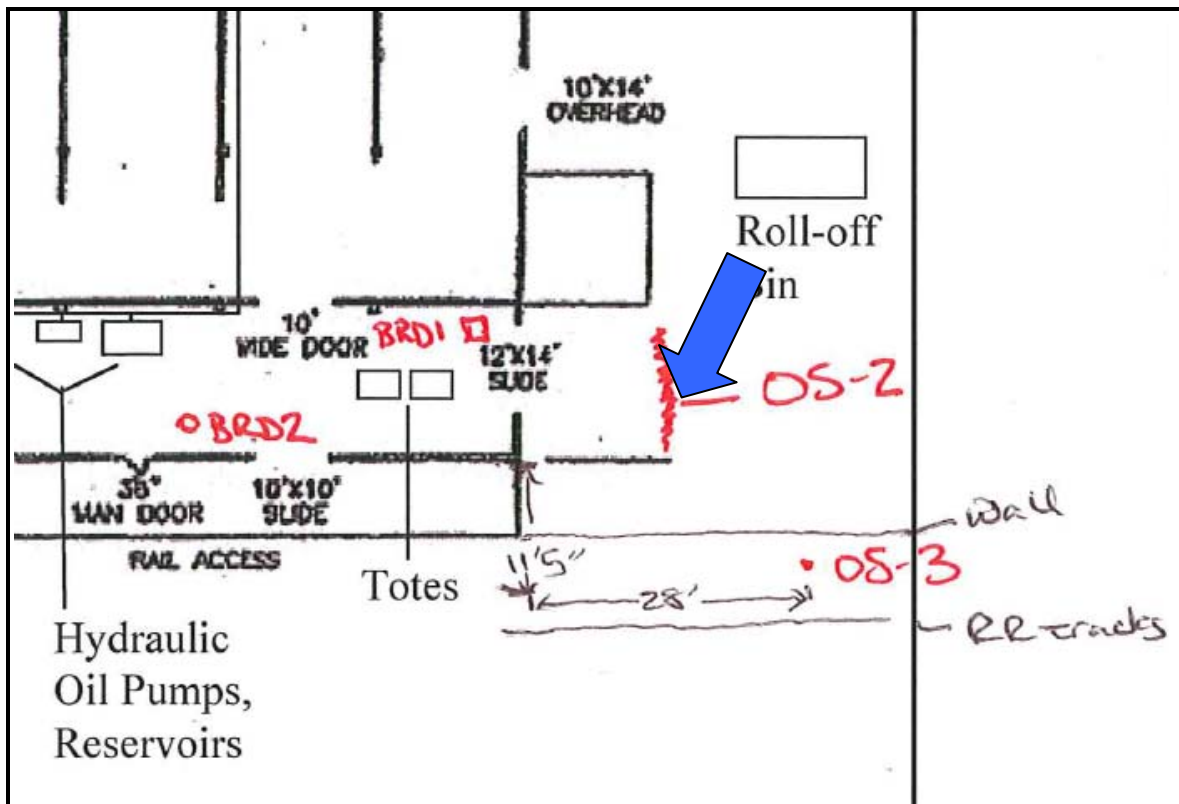
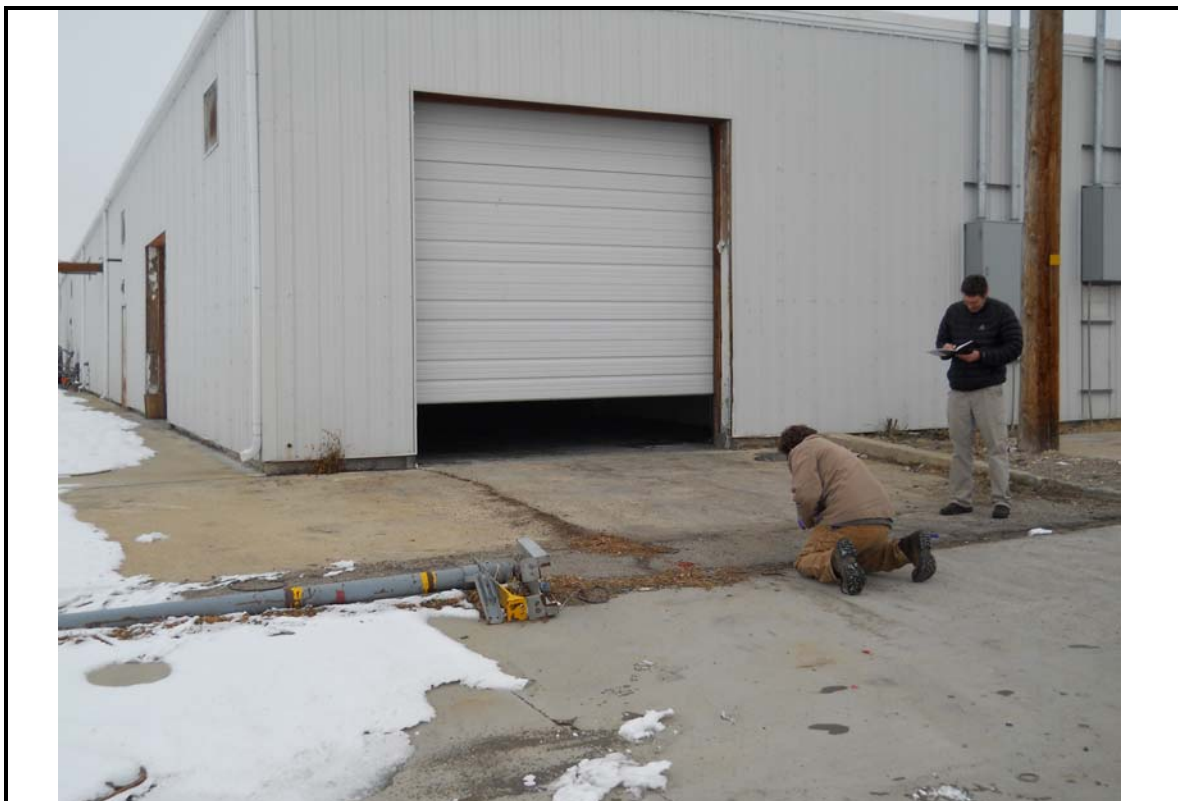
Sample OS-2
114 ppm
Collected by EPA 12-20-11

A concrete sample (composite of 3 individual samples) was taken from the parking lot in the area of the former MP Environmental bin (SW-1). This sample was taken at the request of Cheryl Turcotte of the EPA where historical photos showed plastic totes of oily absorbent outside the bin. The result was 0.30 ppm PCBs (meets the cleanup goal). The EPA also collected a sample of soil from the seam in the concrete in this same area, near the roll-up door to the boiler room (OS-2). The result was 114 ppm PCBs.

Recommendation: We recommend removing the soil from the seam in the concrete. Because the soil will be removed from the seam through the cleaning, there will be no soil remaining and no need to take a soil confirmation sampling in this area.

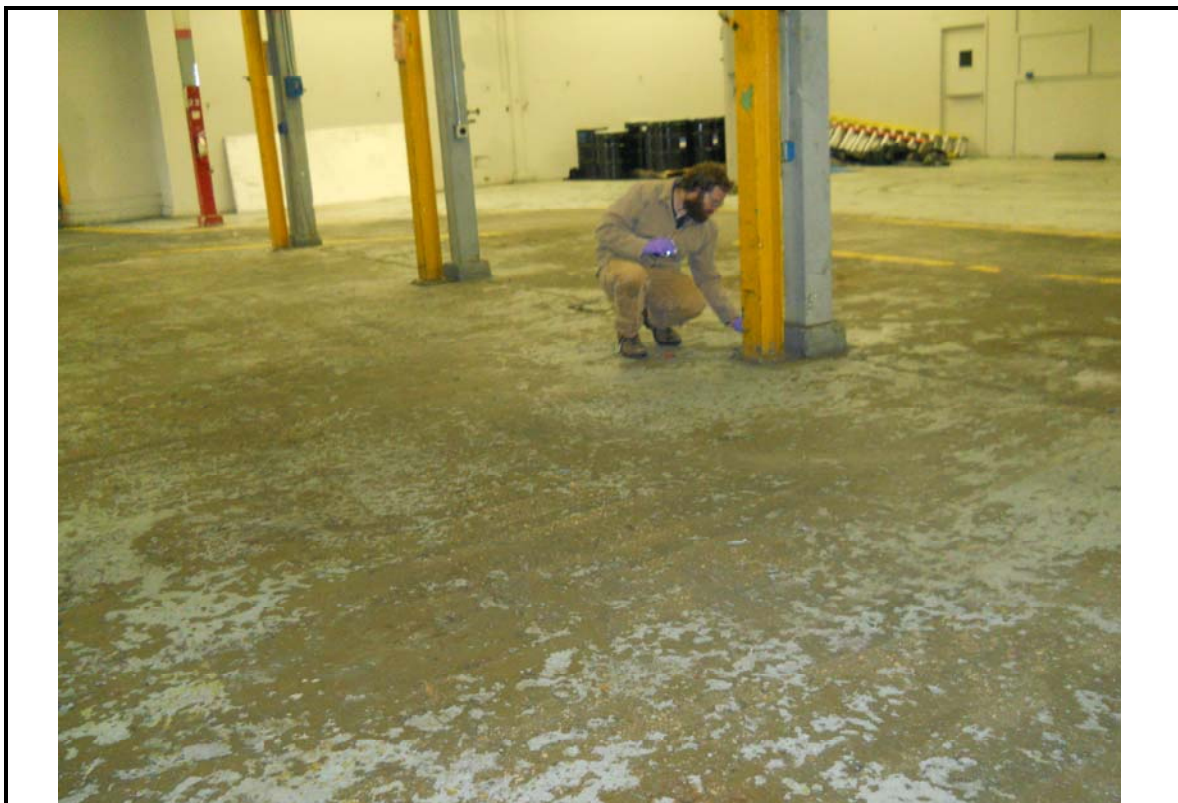
Sample PR-P
72.4 ppm
Collected by EPA 12-20-11

The EPA collected samples of debris at the base of the pillars in the Press Room. The debris contained 72.4 ppm PCBs.

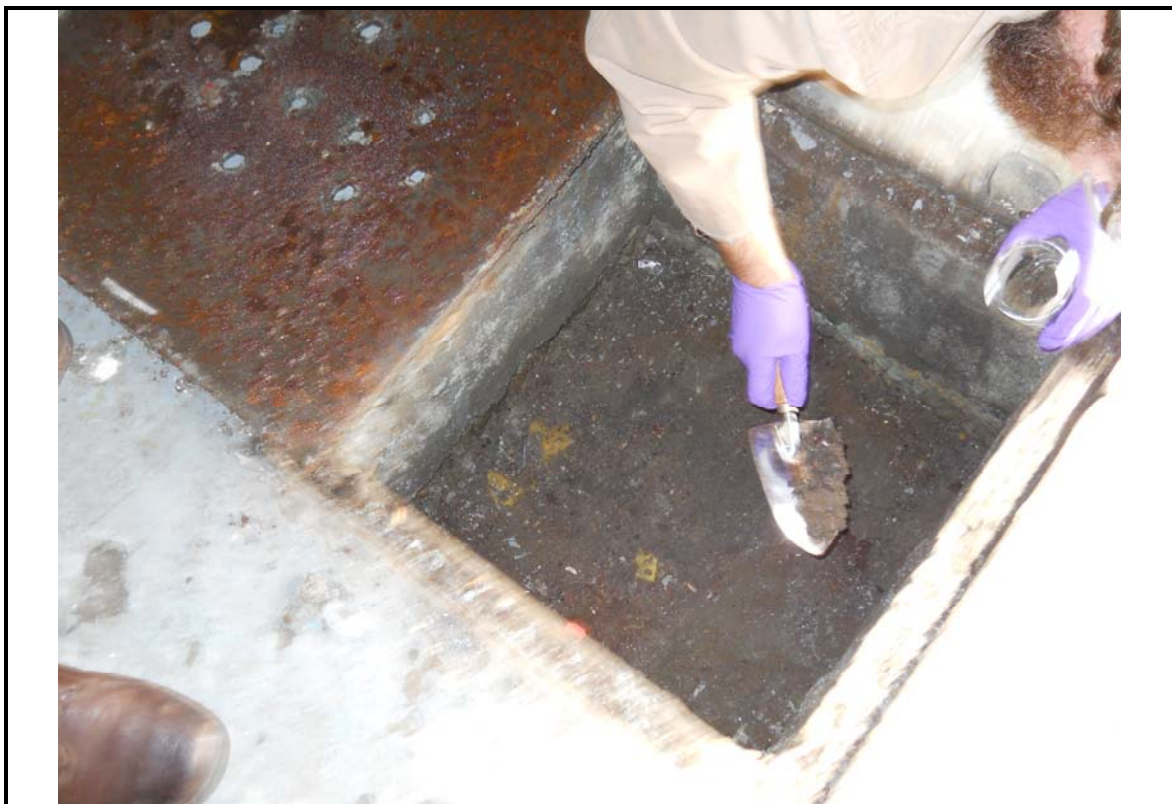
Sample BRD1
5.62 ppm
Collected by EPA 12-20-11

The EPA collected samples from within each of the two floor drains in the Boiler Room. The drain closest to the roll-up door consists of a sump in the floor with a pipeline leading from the sump in the direction of the drain near the center of the room. The drain near the center of the room has a pipe leading straight down for several inches. After several inches, the pipe is obstructed and it is unclear whether the pipe continues downward, turns, or is grouted.

For the drain closest to the roll-up door (sample BRD1), the EPA collected a sample of the dirt in the sump. The result was 5.62 ppm PCBs. For the drain in the center of the room (sample BRD2), the EPA collected a sample of the debris that was in the pipe below approximately three inches of water. The debris appeared to be rusty metal flakes. The result was 20.1 ppm PCBs. According to the UID, floor drains in the UID buildings previously led to a site wastewater treatment system. The system has since been removed, and the UID stated that the lines from the buildings have been grouted closed. ERM was unable to confirm in the field that the lines are grouted.

Recommendation: It appears, based on concrete cuts (and repairs) in the floor that the pipe that leads from the drain sump near the roll-up door connects to the drain near the center of the room. It is unclear where the drain in the center of the room leads. ERM intends to clean out as much of the dirt as possible in the drain sump near the roll-up door and then snake both drains to confirm whether the lines are grouted, as stated by the UID.

If ERM is able to confirm that the line from the drain near the center of the room is grouted to a point below the floor level, we will clean the drains and the pipeline between them by pressure washer and remove as much grit and debris as possible. ERM will pour additional grout to close the drains off to the floor level.

If ERM is unable to confirm that the line from the drain is grouted, we will remove the material from the drain and pipeline to the extent possible without introducing additional water. ERM will then pour a grout seal to prevent future movement of material in the lines.

In either scenario, the lines will be filled with grout to the floor level. If PCBs do remain along the interior surface of the pipes, they will no longer be mobile or accessible. ERM does not intend to collect any samples from the drains.

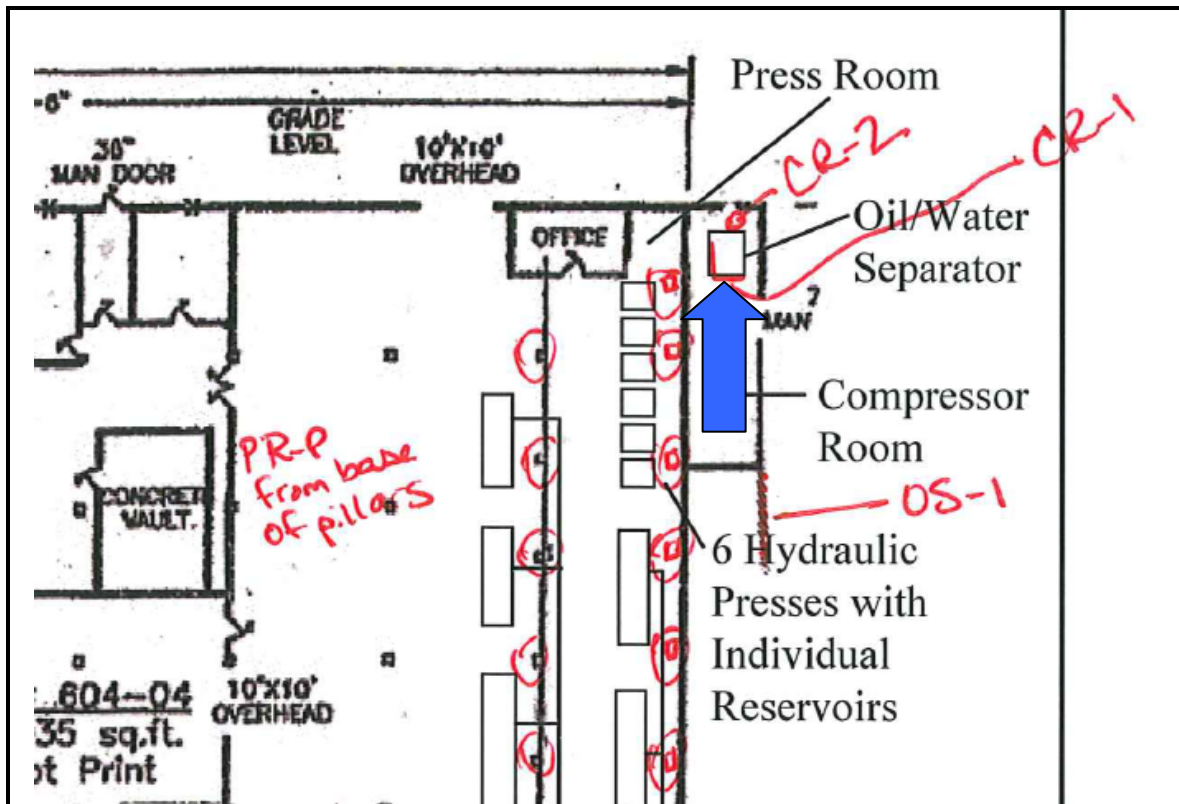
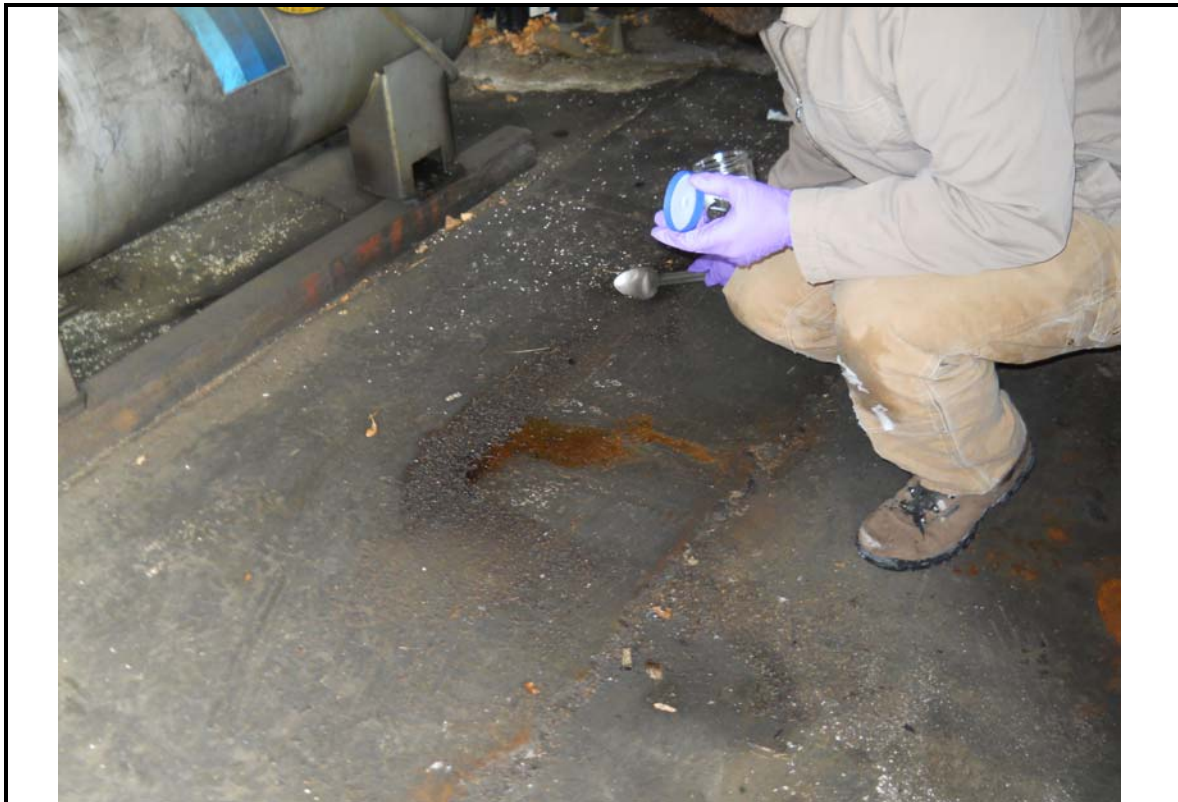
Sample CR-1
55.2 ppm
Collected by EPA 12-20-11

When the oil/water separator was removed from the Compressor Room, a floor drain was observed to be located behind the former oil/water separator location. ERM collected a sample of the oil and absorbent on the floor of the Compressor Room. The result was 57 ppm PCBs. The EPA also collected a sample of the oil and absorbent on the floor of the Compressor Room. The result was 55.2 ppm PCBs.

Recommendation: We plan to remove the debris from the Compressor Room floor and perform an aggressive cleaning of the concrete around the former oil/water separator. Following the floor cleaning we will sample the accessible areas of the floor (without removing the other equipment in the room) using a 1.5 meter sampling grid and compositing up to nine sample points into a single composite sample.

Prior to the cleaning, we will snake the drain to determine whether it is grouted. If the drain is grouted, we will clean it by pressure washer to remove the debris above the grout seal to the extent practicable. If ERM is unable to confirm that the drain is grouted, we will remove debris from the drain to the extent practicable without introducing additional water. ERM will then pour a grout seal to prevent future movement of material in the line.

In either scenario, the line will be filled with grout to the floor level. If PCBs do remain along the interior surface of the pipes, they will no longer be mobile or accessible. ERM does not intend to collect any samples from the drain.

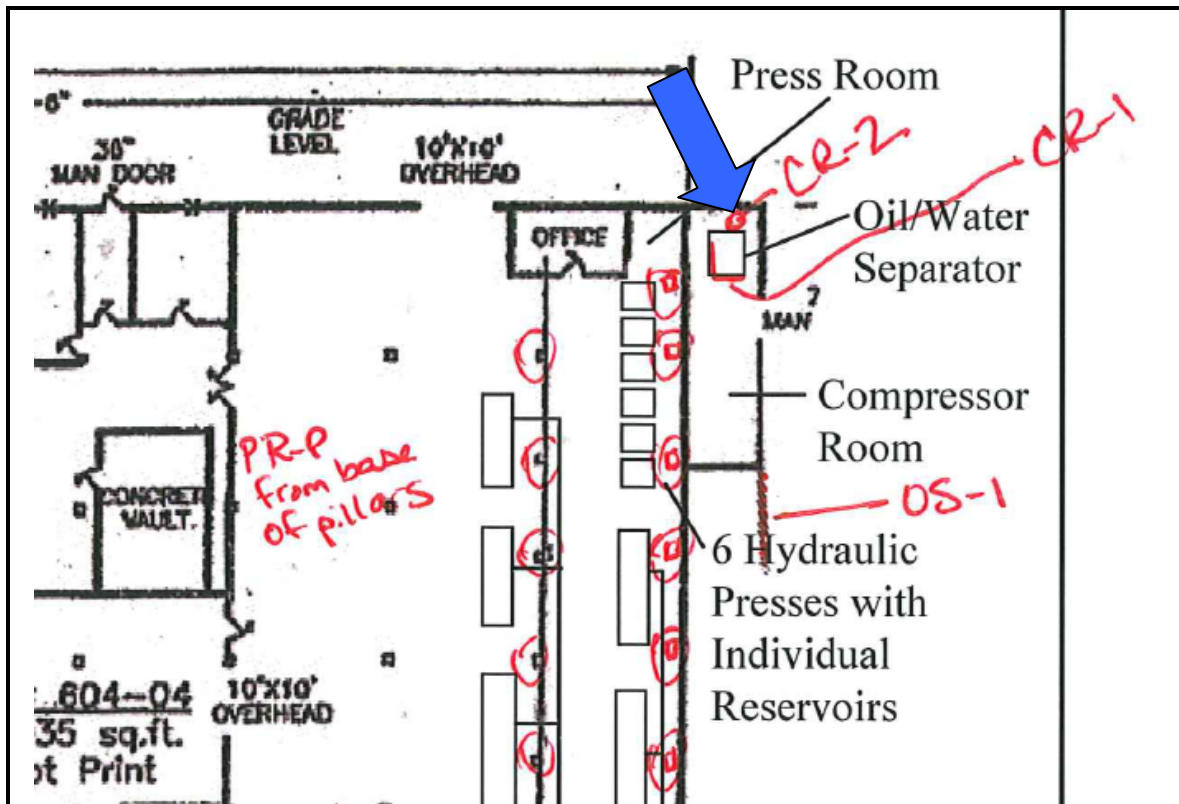
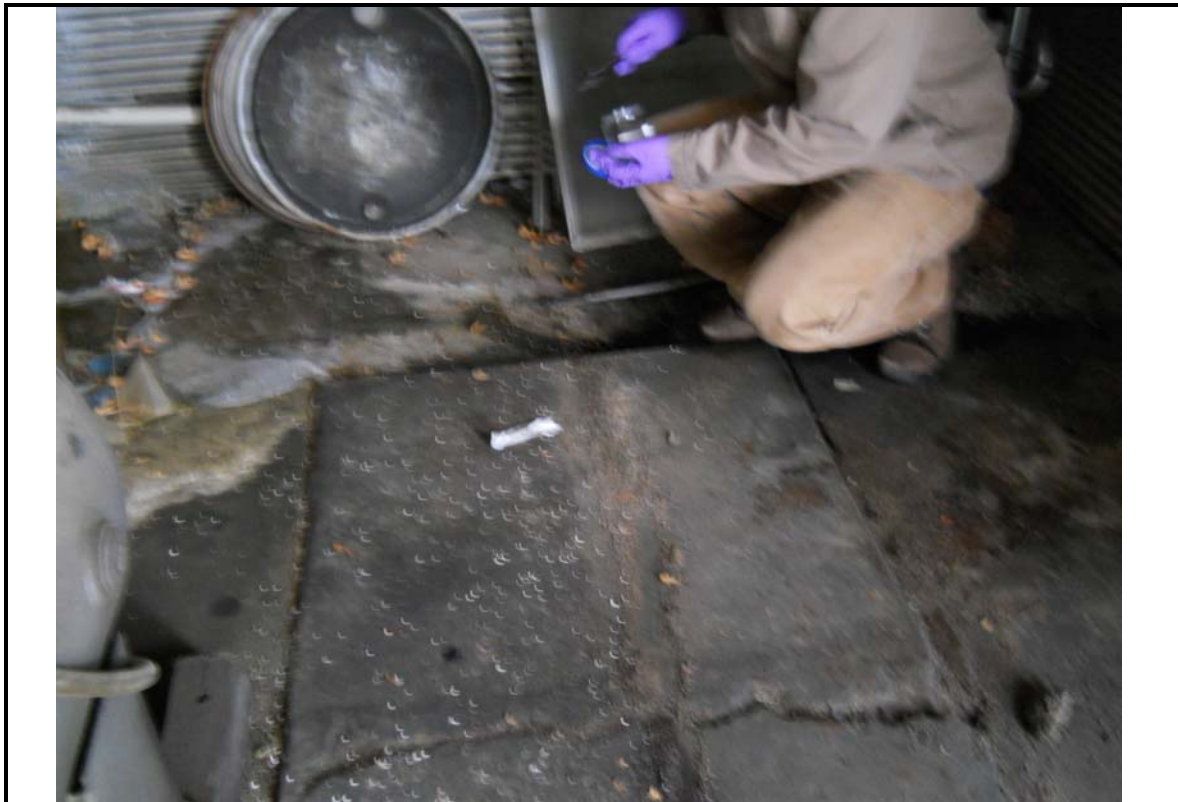
Sample CR-2
48.4 ppm
Collected by EPA 12-20-11

The floor drain in the Compressor Room has a pipe leading straight down for several inches before it is blocked with debris. The EPA collected a sample of the debris from the floor drain; the debris appeared to be a mix of dirt, absorbent, and possibly some oil. The result was 48.4 ppm PCBs. Because the pipe is obstructed, ERM was unable to confirm in the field whether the line is grouted, as indicated by the UID.

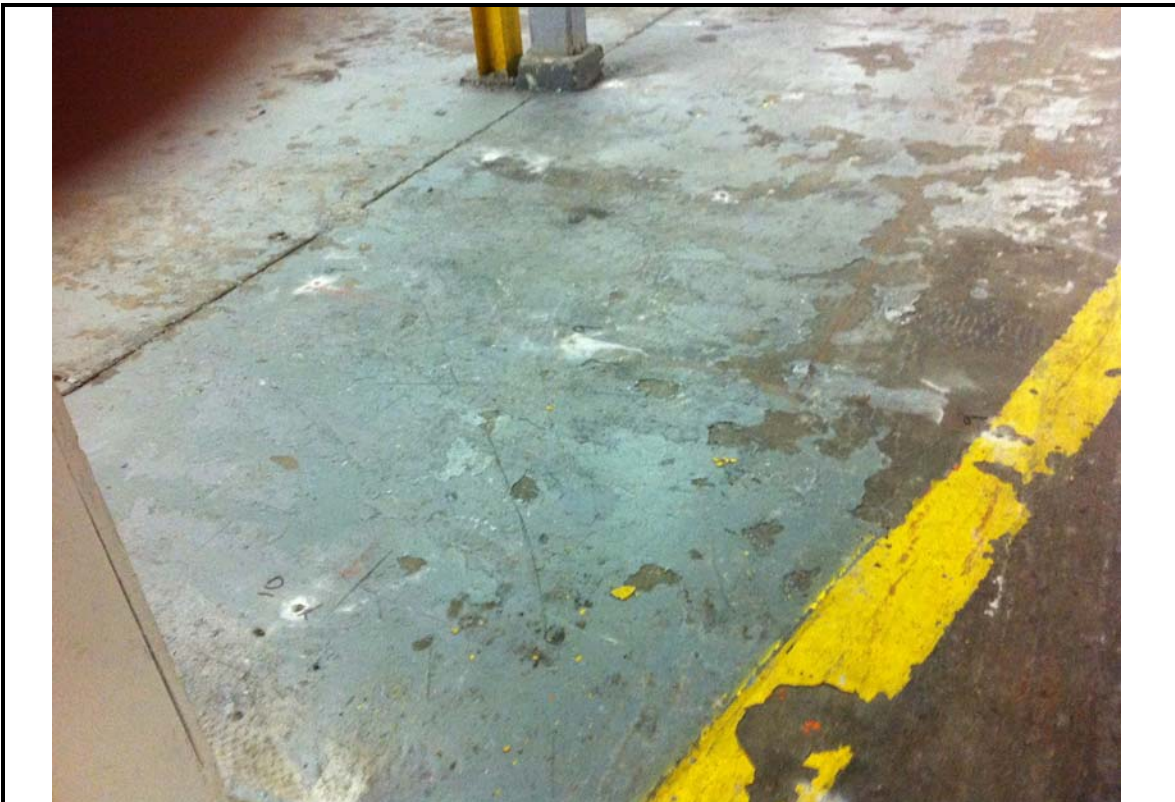
Sample PRNE-1 - PRNE-10
0.15 to 71 ppm (see Table 1)
Collected by ERM 12-27-11

ERM collected and composited concrete samples from the northeast portion of the Press Room floor following the floor cleaning by Americon. The results show that the area closest to the office/roll-up door meets the cleanup goal; however, the portion of the floor more directly under the press equipment does not meet the cleanup goal, with results ranging from 1.5 to 71 ppm.

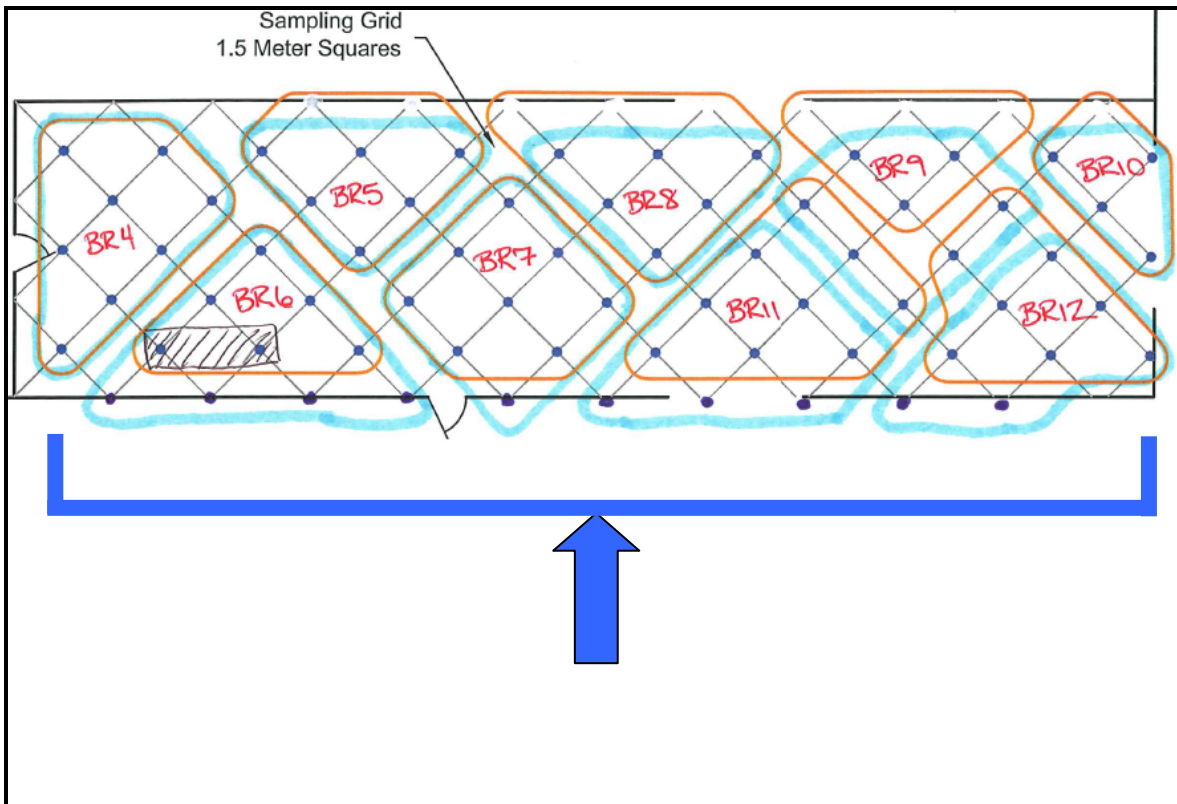
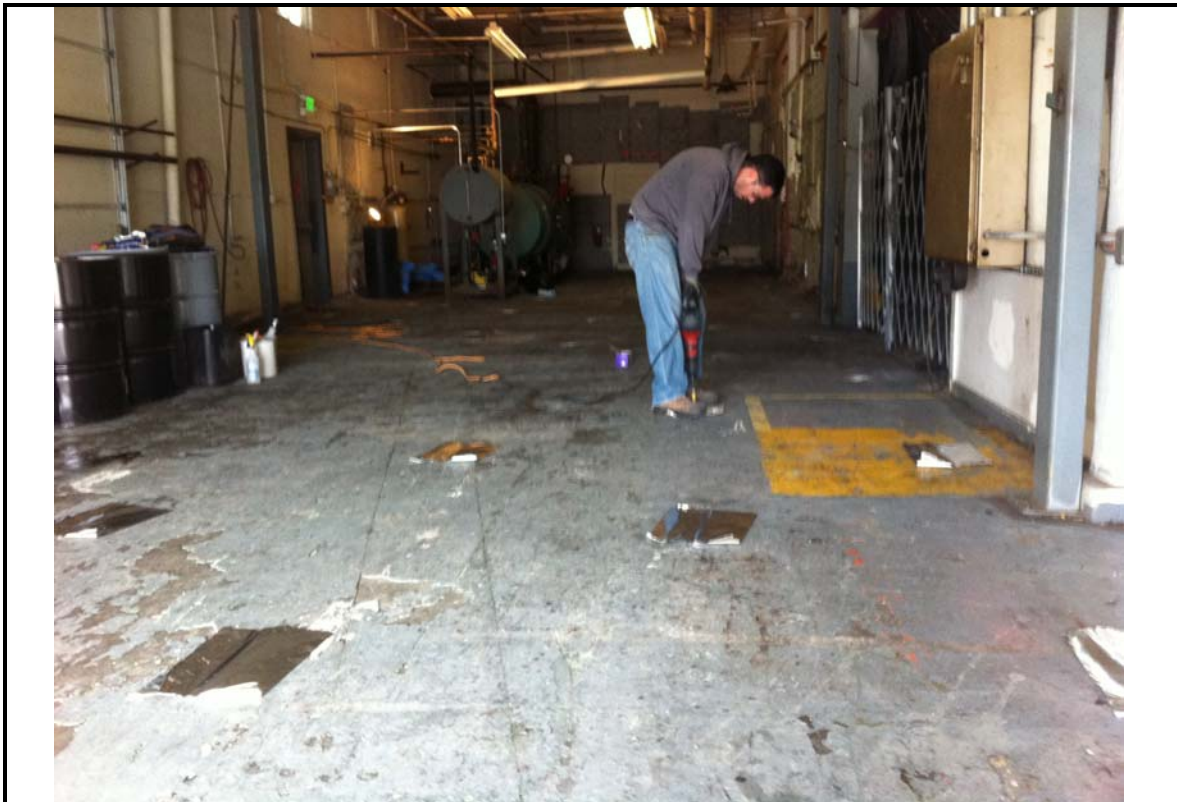
Sample BR-4 - BR-12
0.31 to 6.9 ppm
Collected by ERM 12-30-11

ERM collected and composited concrete samples from the Boiler Room floor following the floor cleaning by Americon. The results show that the southern third of the floor (nearest the roll-up door) meets the cleanup goal of 1 ppm. The northern two-thirds of the floor had results in the 1.3 to 6.9 ppm range.

Recommendation: We plan to perform an aggressive recleaning of the area of the floor that did not pass with a different detergent and allow time for the cleaner to soak in before scrubbing. Following the recleaning we will resample the portion of the floor that has not already met the cleanup goal using the same confirmation sample grid proposed in the original work plan.
